2 BUZZARD SWAMP WATERFOWL AREA

3 NO. 6 DAM

8 PHASE I INSPECTION REPORT

1 NATIONAL DAM INSPECTION PROGRAM

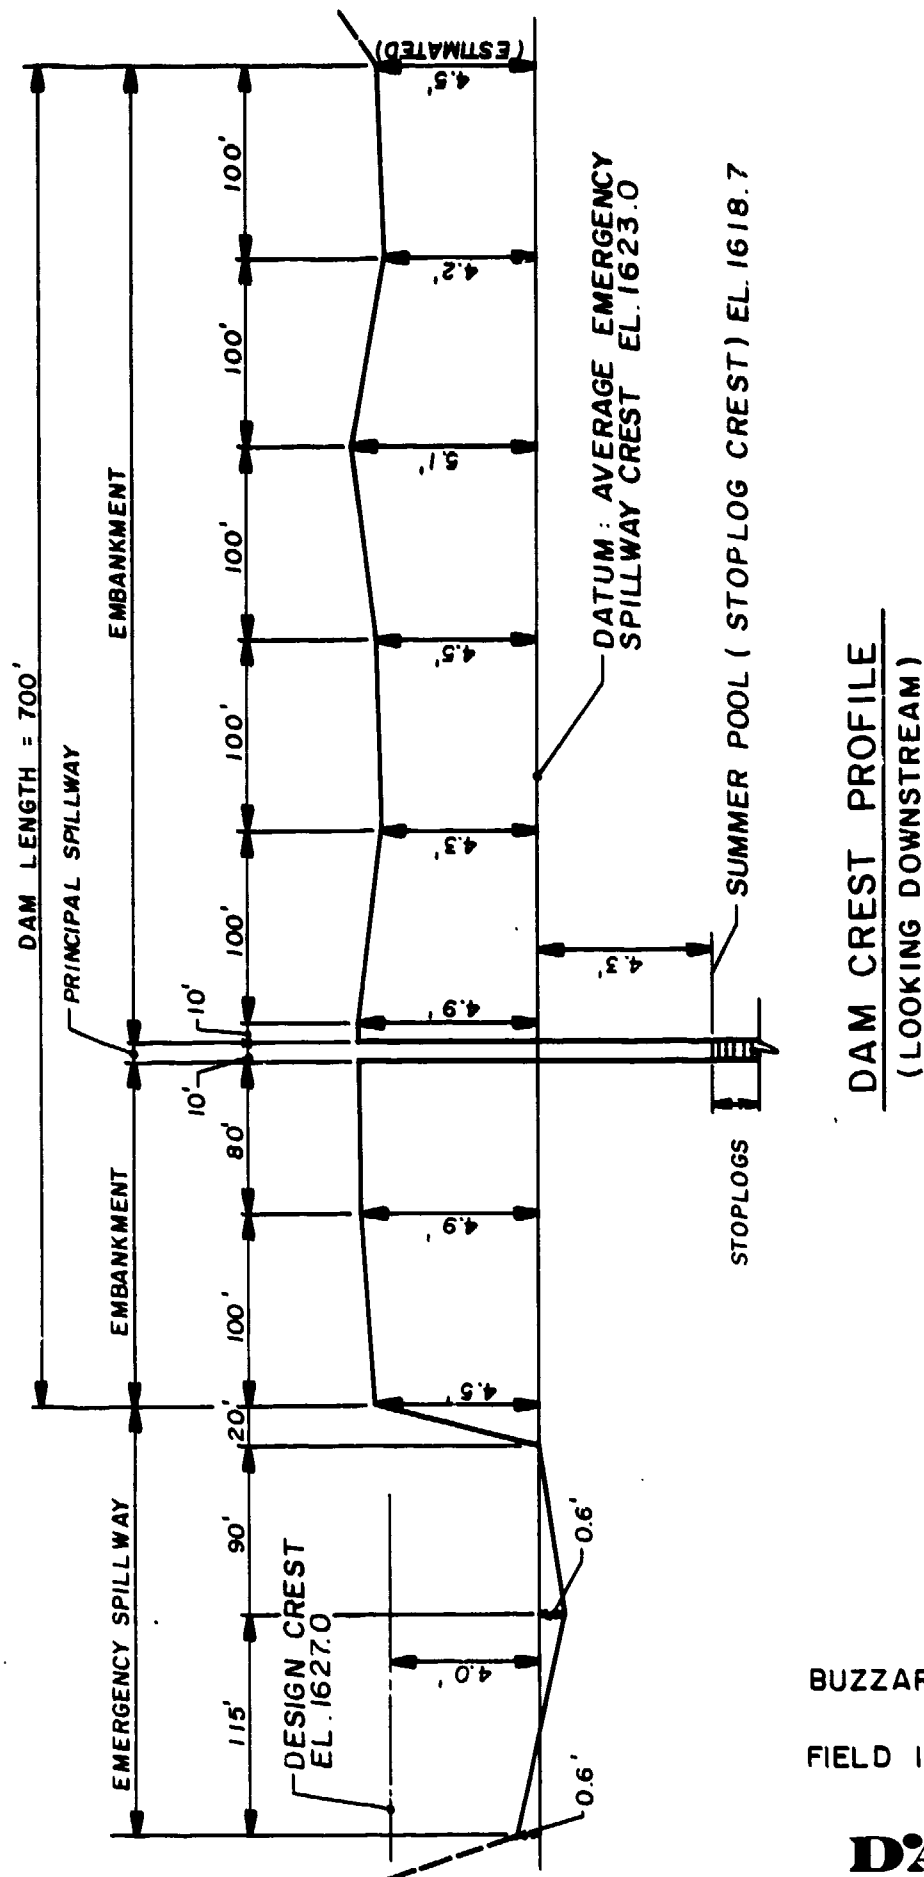
DAM CREST PROFILE
(LOOKING DOWNSTREAM)

The dam crest was surveyed relative to the emergency spillway crest elevation and was found to be at or above the design level. The lowest embankment area occurred at a section near the right abutment. The dam crest profile, according to field measurements, is illustrated on Plate 10.
